Super Salvage, Inc.
Industrial Stormwater Inspection Report

Appendix B

Photograph Log and Photographs

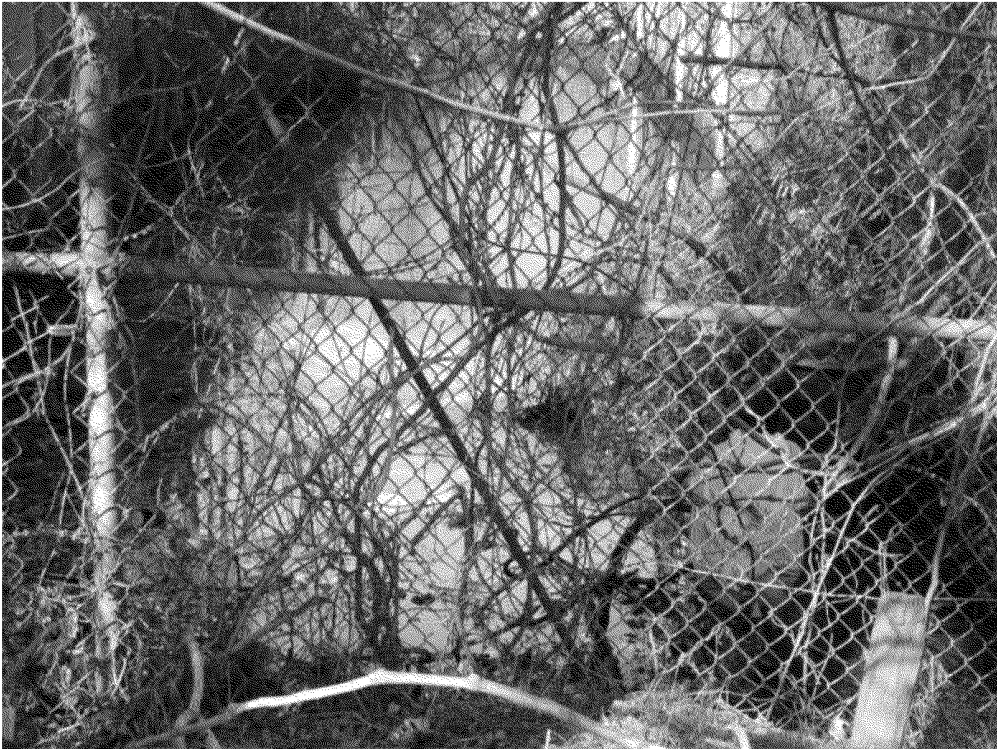
Photograph 5. Overall view of the large runoff collection pond.

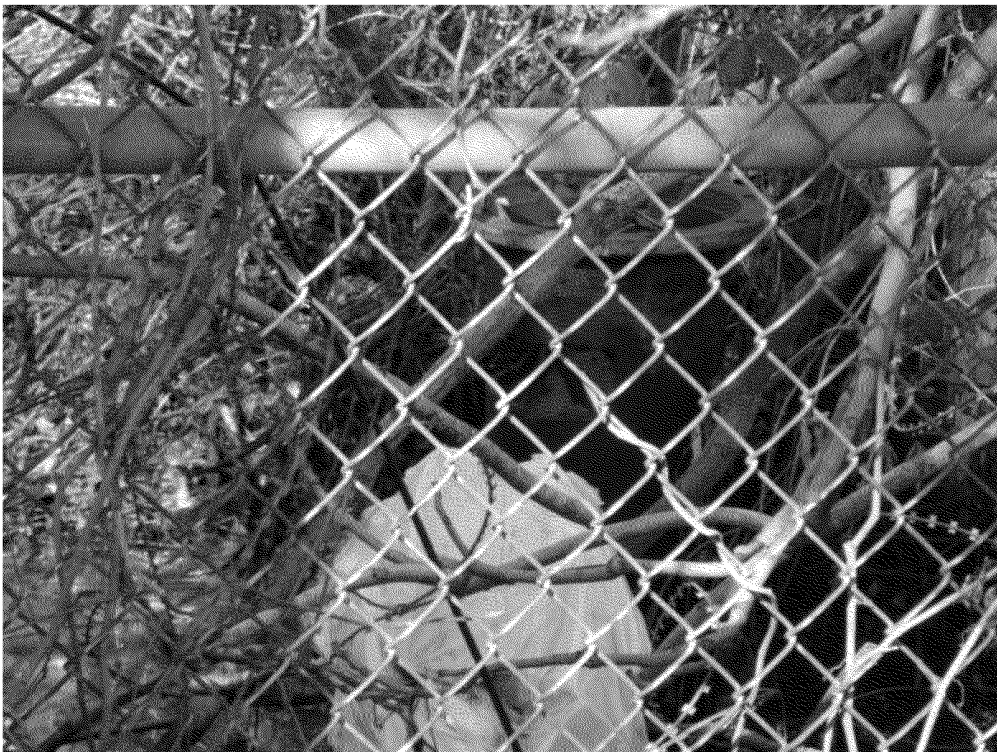
Photograph 6. The riser in the large runoff collection pond.

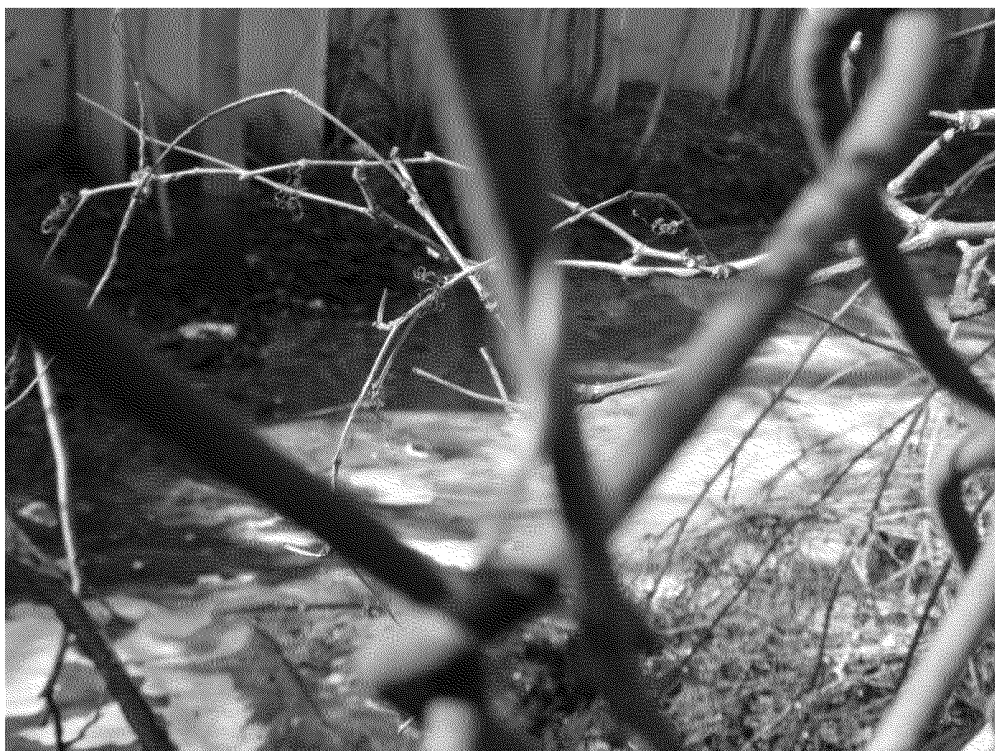
Photograph 9. View of the sheen on the large runoff collection pond.

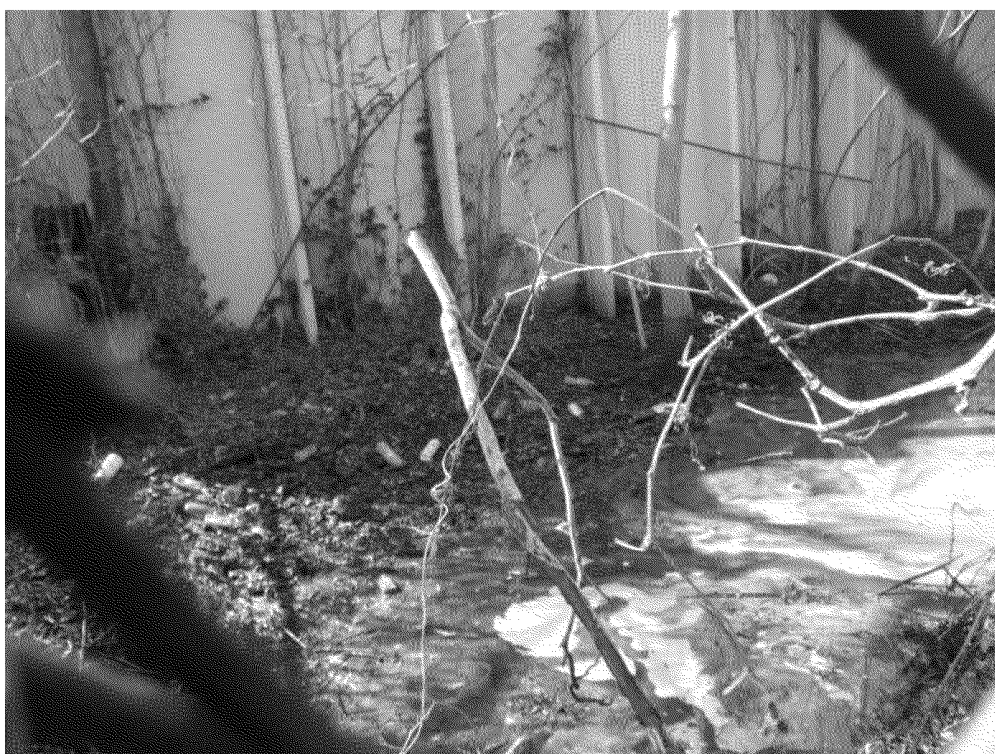
Photograph 10. View of the sheen on the large runoff collection pond.

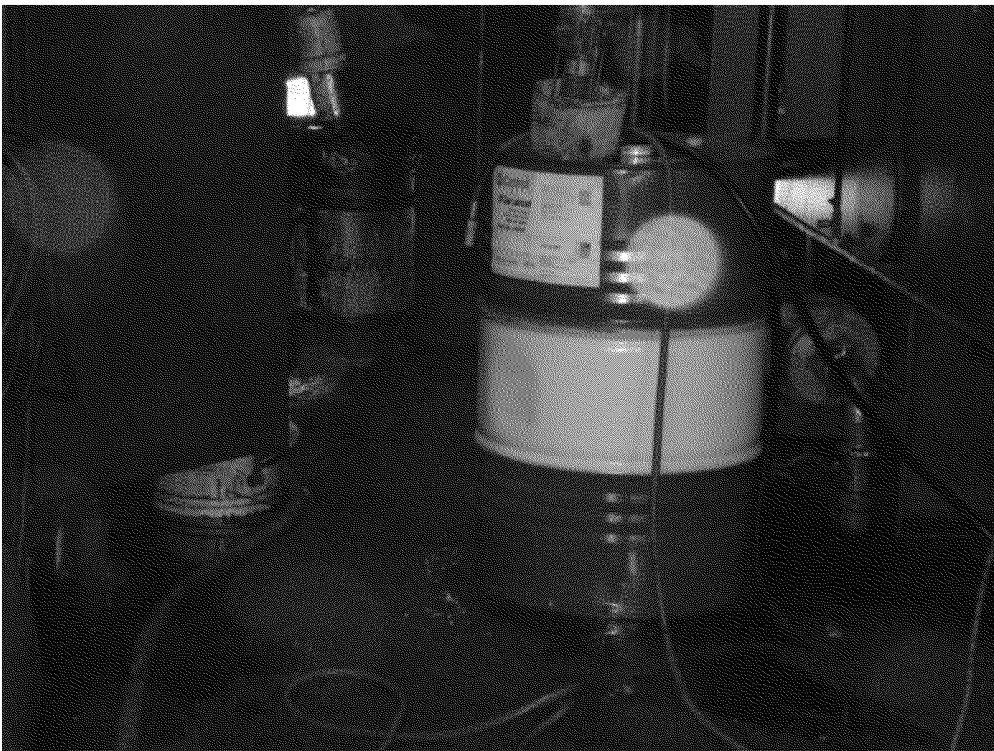
Photograph 22. Close-up of two tanks in the building leaking onto the floor.

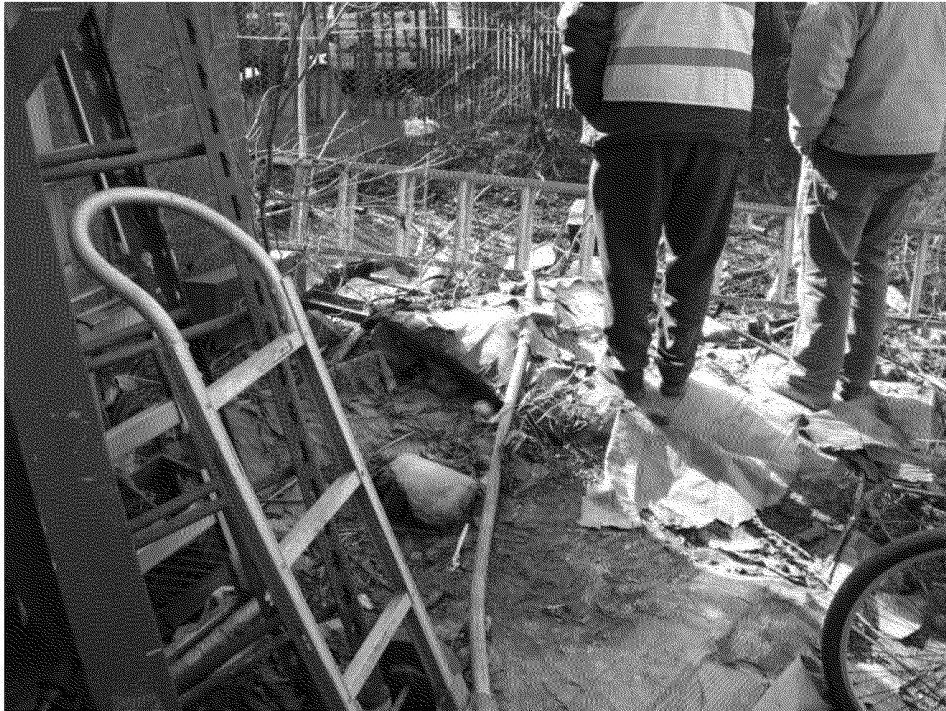
Photograph 35. Red hose leading from the manual pump in the small runoff collection pond to the large runoff collection pond.

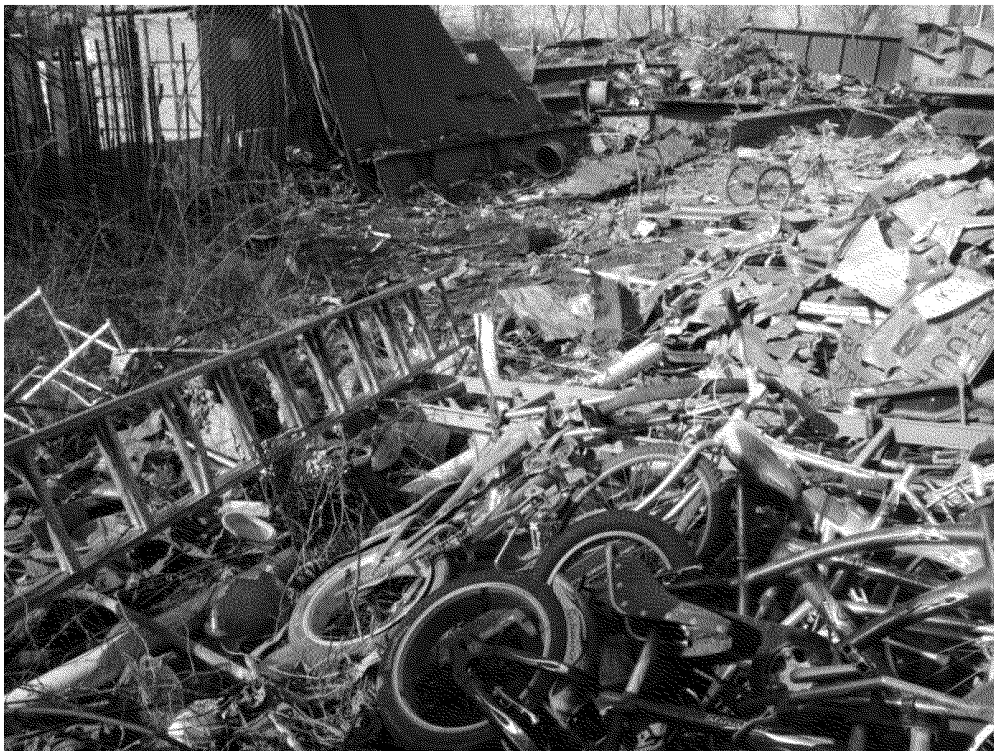
Photograph 36. View of debris just right of the large runoff collection pond.

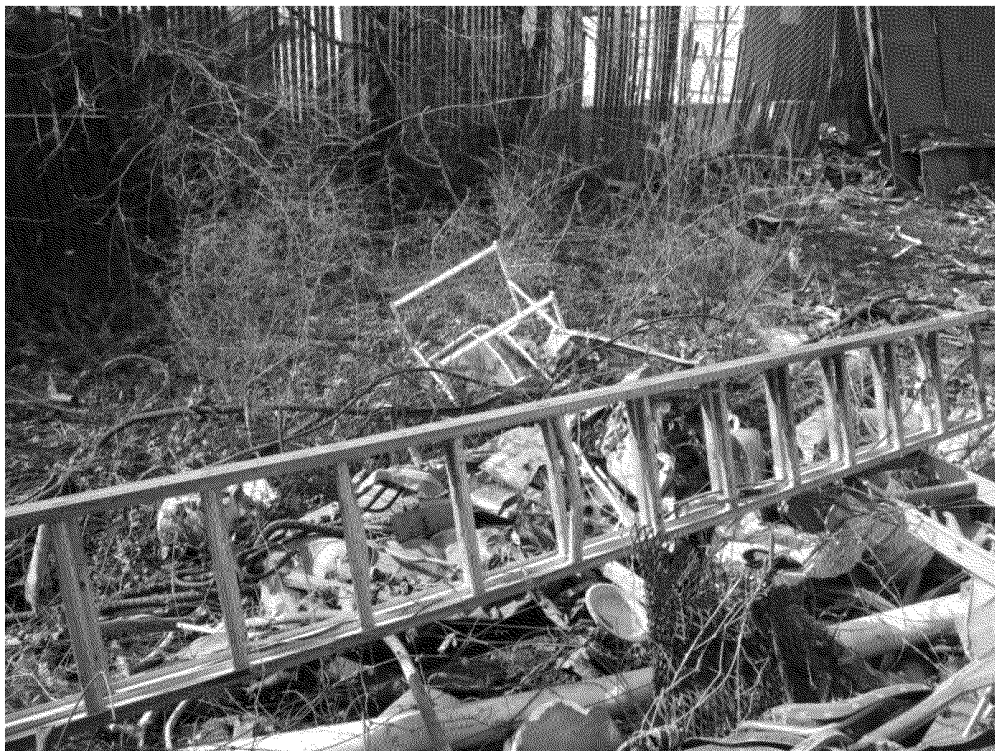
Photograph 37. Alternate view of debris adjacent to the large runoff collection pond.

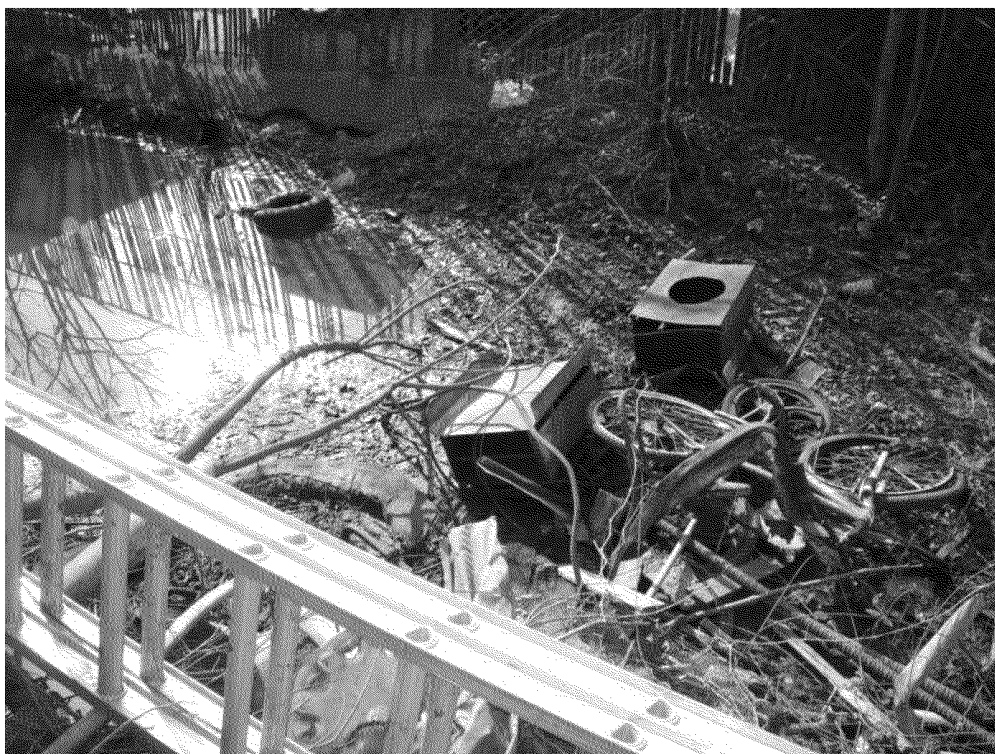
Photograph 38. Ladder next to the northern end of the large runoff collection pond.

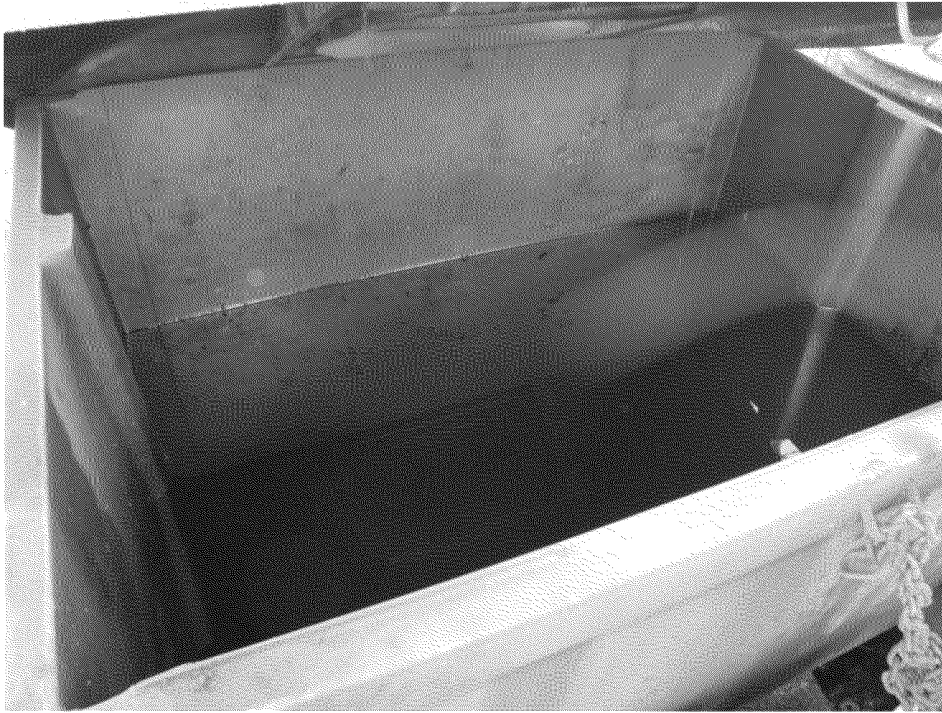
Photograph 71. Plastic container/dumpster of what appears to be waste oil adjacent to the property boundary.

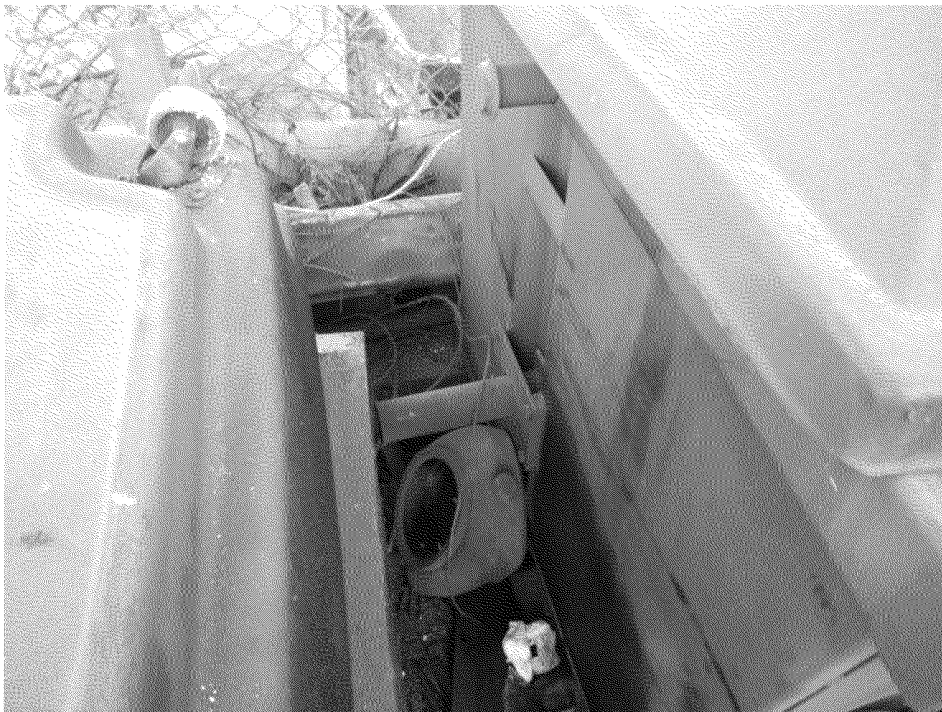
Photograph 72. Alternate view of container from Photograph 71 showing exterior staining.

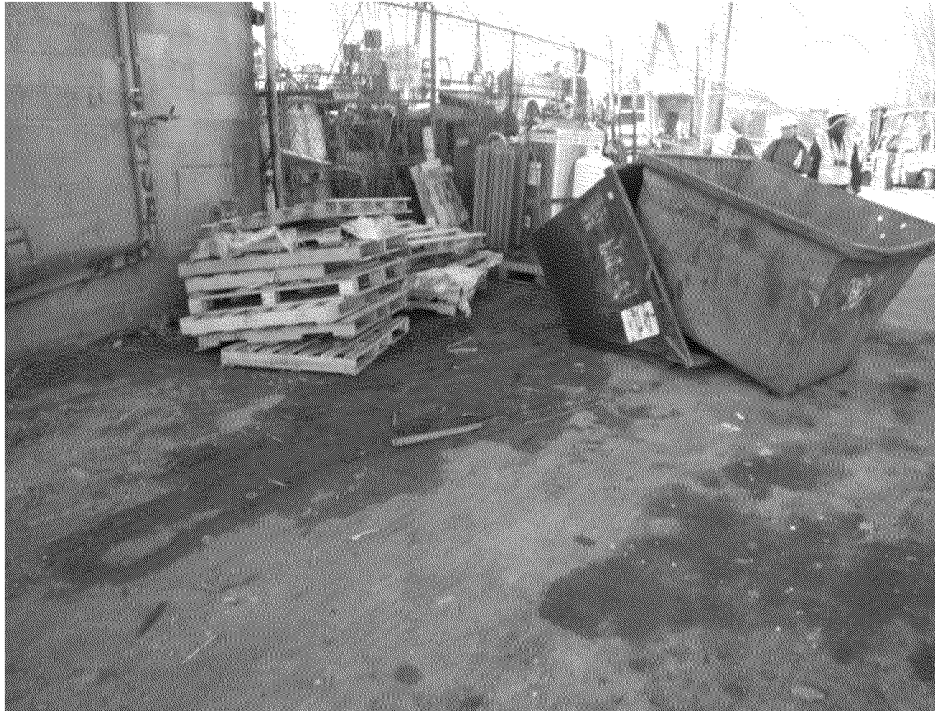
Photograph 75. **Staining on the ground outside of the perimeter fence near dumpsters.**

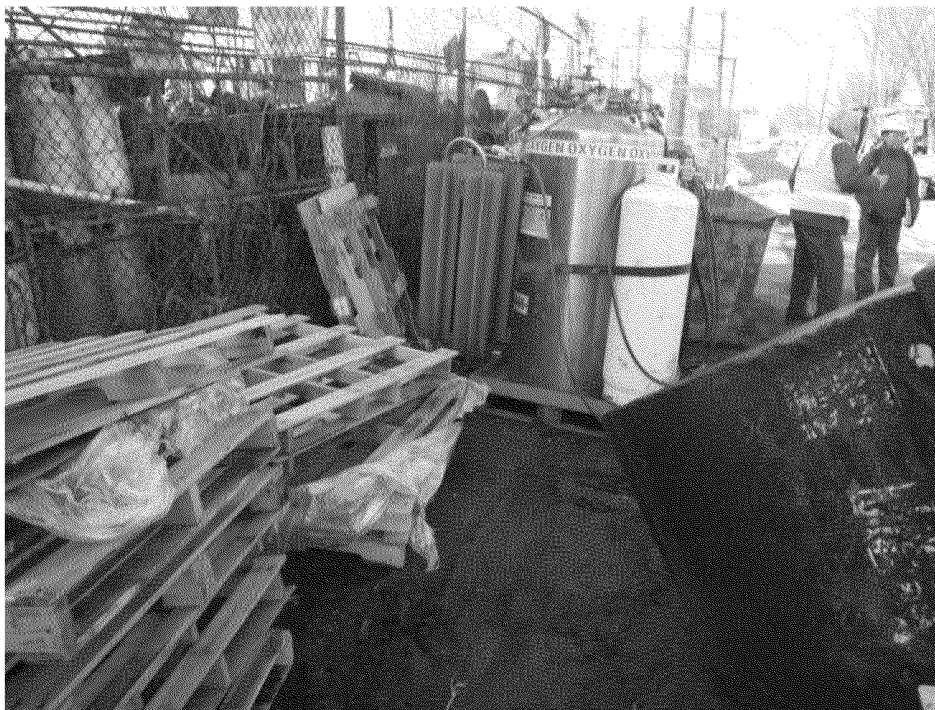
Photograph 76. **View of items stored the outside of the perimeter fence.**

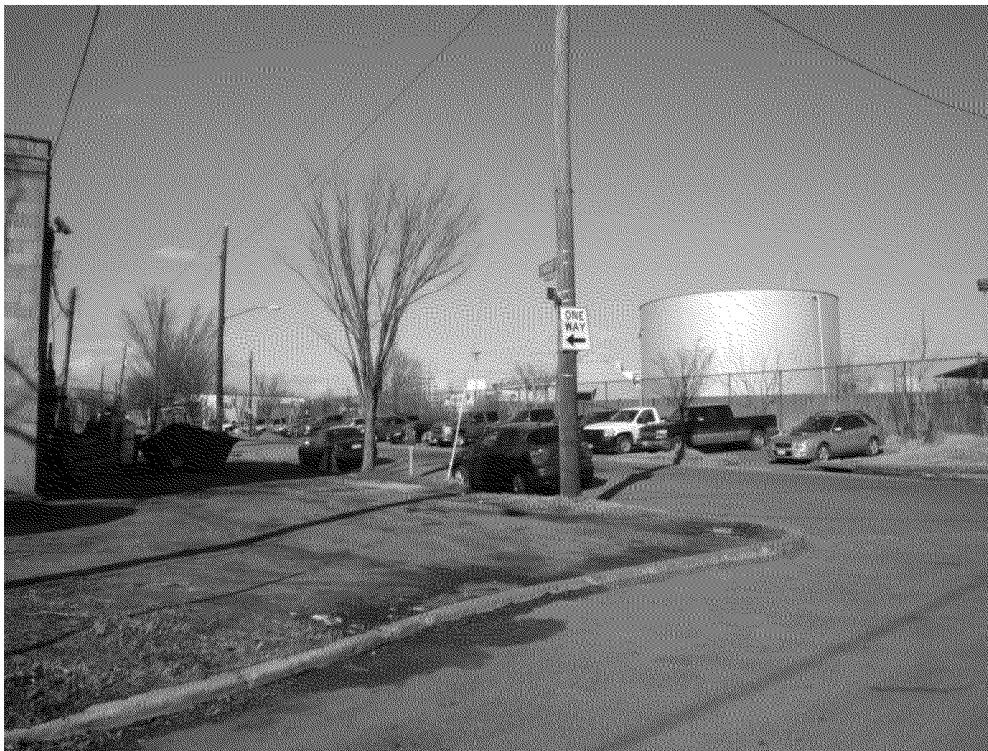
Photograph 82. Staining at the intersection of First Street SW and S Street SW.
